Manhole Inspection Summary

Manhole # S71U__015MH

Insp Date: **4/16/08 2:07 PM**

Location Address: **6706 Brentwood Ave.**

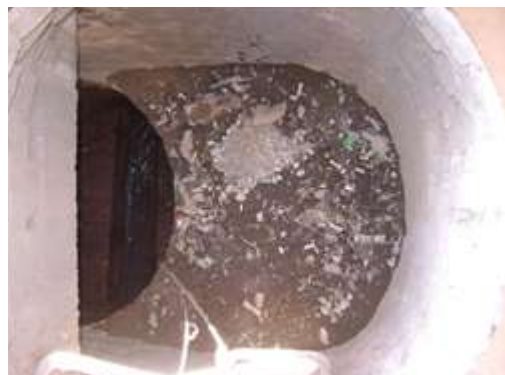
Top View

Comments **3 FT DOWN THERE IS A 4 FT LONG SHELF.**

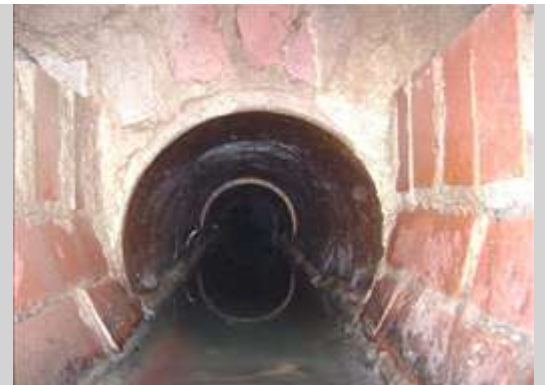
6 O'Clock Inflow

8 in. Circular Gravity Sewer
Pipe In @ 6 O'Clock

Pipe Height: **8.4** (in.) Rod and Bar (Angled)
Pipe Material: **Clay** ☐ Pipe Lined
Invert Depth: **9.58** (ft.) Flow Characteristics: **Slow**
Deposits: ☒ None ☐ Mud ☐ Sludge ☐ Debris ☐ Grease
Silt Depth: (in.) Deposits Extent:
Infiltration: **None** Pipe Seal Cond: **Sound**
